**MARYLAND HISTORICAL TRUST
DETERMINATION OF ELIGIBILITY FORM**

Property Name: Lynch Farm Inventory Number: HA-2177
Address: 2523 Carsins Run Road Historic district: ☐ yes ☒ no
City: Aberdeen Zip Code: 21001 County: Harford

Project: Section 200: I-95, North of MD 43 to North of MD 22 Agency: Maryland Transportation Authority

Lynch Farm

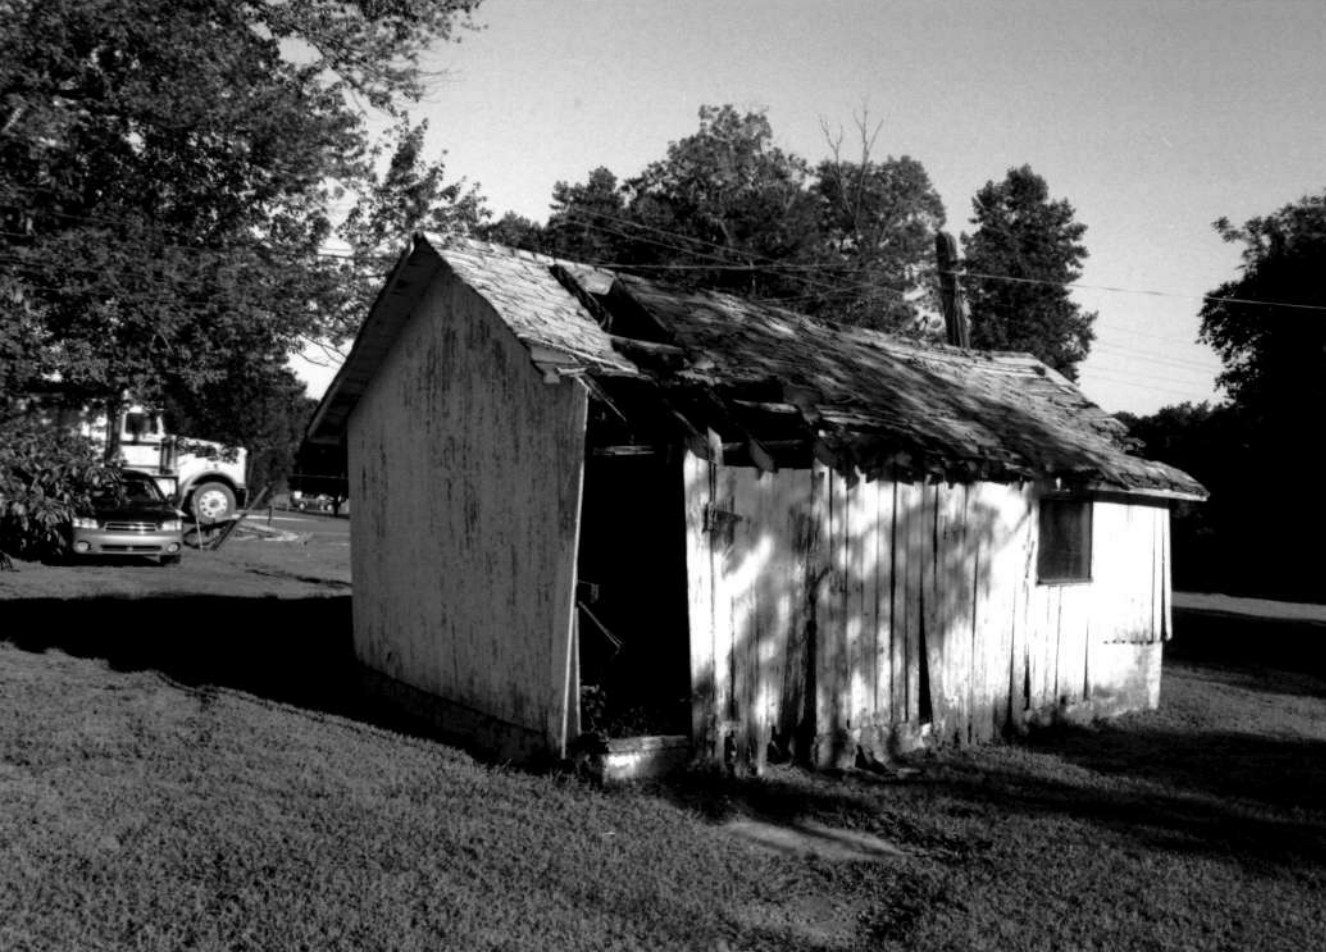
#6 of 10

The property includes several outbuildings, all of which are in poor condition. A one-story, side-gabled, white-washed timber frame shed sits to the northwest of the dwelling. The building sits atop a foundation comprised of poured concrete and concrete block. Two, six-light, fixed-sash, wooden windows are located on the east elevation. A set of double-leaf, timber frame doors, attached with metal strap hinges, is located on the west elevation.

Shed - east & south elevations; view to northwest

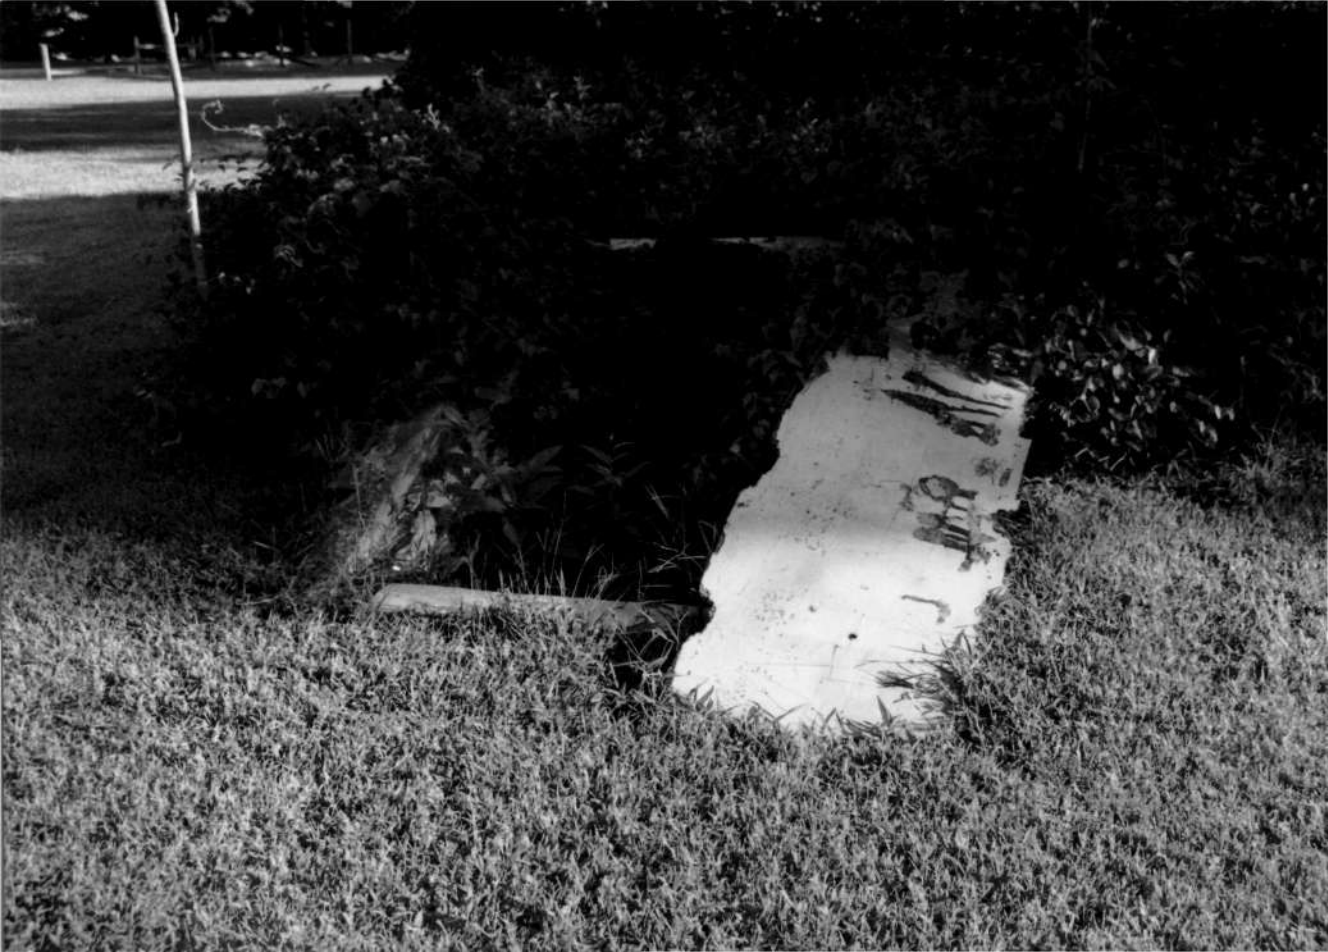
7 of 10

An underground storage cellar, detached completely from the house, is situated to the north of the shed. A partially banked ramp denotes the entrance into the cellar, which is comprised of fieldstone walls. Ivy conceals the top of the ramp so that further details are not discernible.

entrance to detached root cellar

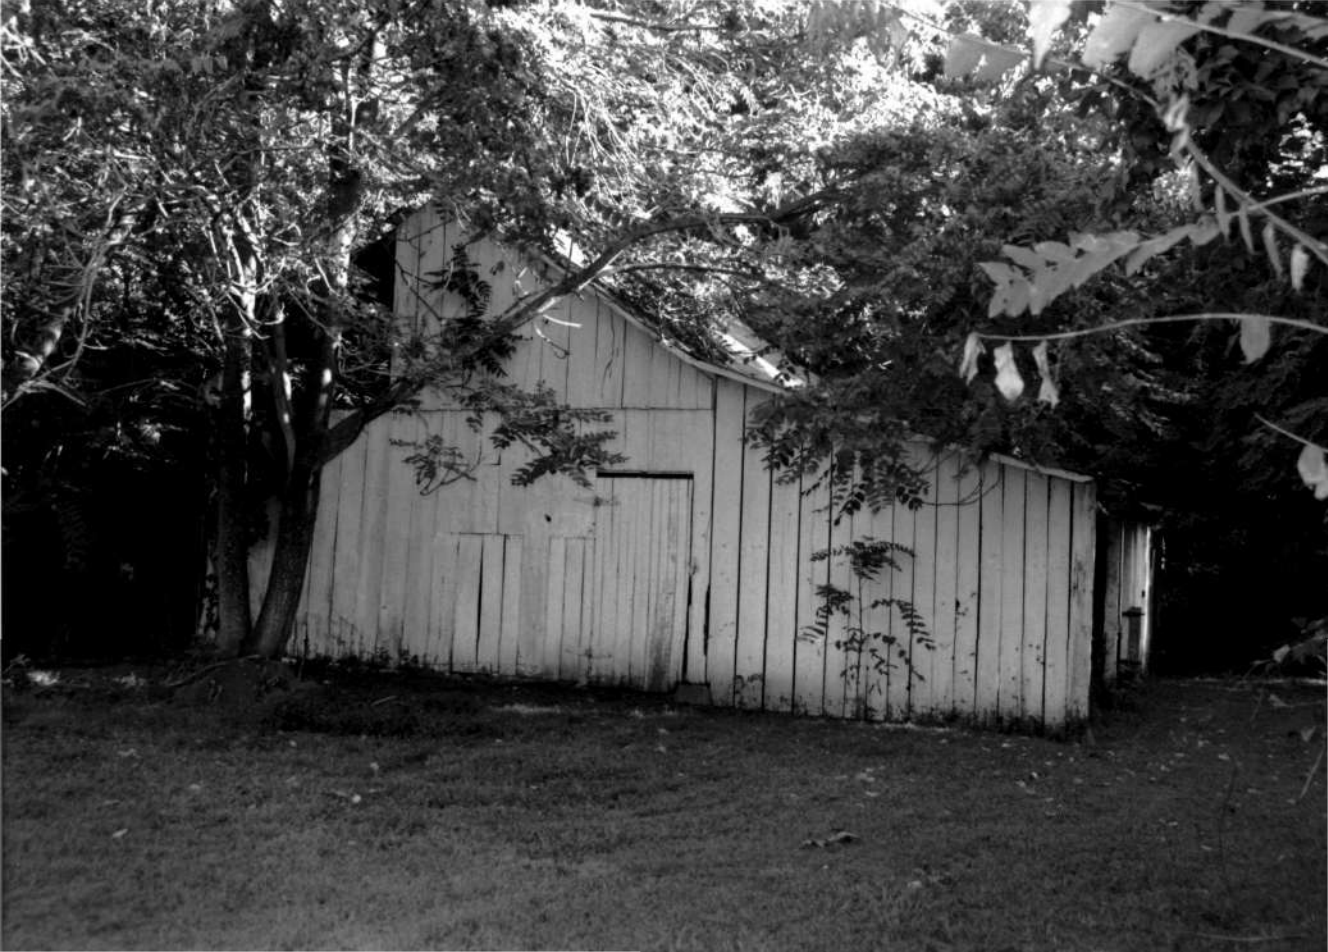
10 of 10

A one-and-a-half-story, front-gabled, whitewashed vertical board barn occupies the far northern corner of the building cluster. The building contains a one-bay, shed-roof extension off of the west elevation. Dense vegetation prevented any further investigation of the building.

Gable Barn-south elevation; view to north
